INTERNATIONAL JOURNAL CONSERVATION SCIENCE

NOT JUST SIMPLE WATER DRIPS: THE CASE OF AN EARLY 1900s OIL PAINTING ON STONE

Nathalie DEBONO ^{1,*}, Roberta De ANGELIS², Francesca Caterina IZZO³

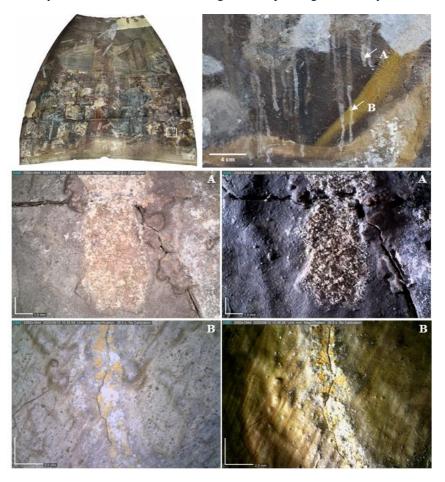
Fig. 1. Context images shows the appearance of the long white drips running down the surface of the paintings, with a macro image on the right. The two sets of micrographs, at the bottom, show the same drip in diffuse and raking light showing the lack of colour and increase in texture in comparision with the surrounding, unaffected area.

In 2020 in view of a conservation project, a new condition assessment and a series of investigations were carried out. Compared to 2004, in 2020 the condition of the paintings was found to have considerably worsened, whilst several areas of the painting had collapsed. One of the aspects that was investigated over the last campaign was the presence of numerous long white drips, probably generated by rainwater infiltration. These drips marks, from now on referred to as "drips" in this contribution, were particularly interesting since along their trail the upper paint layer appeared thinner than in the unaffected areas, while white material was also found to have deposited along the edges and at the end of the drips (Fig. 1).

The white drips are, therefore, likely to be a result of the migration of oil paint components due to water infiltrations that have seeped through the external stone cracks and through the entire stratigraphy of the painting. Recurrent water infiltrations in this case have caused the unbound oil components out of the paint system. The gypsum, on the other hand, was instead probably leached out from old plaster repairs and mortar joints of the stone masonry.

In spite of its limitations, this study pointed out the detrimental effects that prolonged exposure to liquid water can generate in oil-based wall paintings. Besides activating salt activity and related salt deterioration, water can also leach out oil paint components. This emphasises the need of strict preventive measures aiming to avoid rainwater infiltrations, and also of a cautious use of water during conservation treatments.

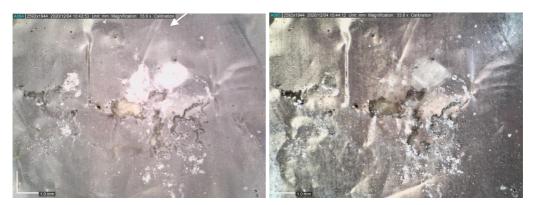
The first few scrapings of the "drips" were collected and stored in aluminium foil then placed in a sealed plastic box. In less than a month, the samples were found to have reacted with the aluminium foil, which as a result, was found punctured and darkened at the edges (Fig. 2). In few cases upon the opening of the aluminium foil a faint, foul smell was perceived. On the spot, the pH of the liquid was tested. It gave a rough result of a neutral pH.

Fig. 2. Micrographs in diffuse and raking light of the reacted aluminium foil. The arrow points at the droplet found within the aluminium foil

At this stage of research, unfortunately, it has not been possible to explain the dissolution of the paint layer along the drip trail, and not even the corrosion of the aluminum foil used to store the samples. The pH results reported above did not give any indication to narrow down any possible causes.

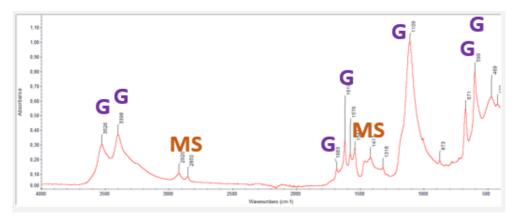
FT-IR in ATR mode and Raman spectroscopy performed on scrapings representing all three morphology of the "drips" gave insights on their organic and inorganic composition. All samples were found to include gypsum and metal carboxylates, also known as metal soaps (Fig. 5). Research in the degradation of oil paintings implies that the metal soap formation within oil paintings is fairly common, however, this research is mostly carried out and aimed for easel painting conservation [13-20]. The characterization of the specific metal soaps, however, was not possible due to the similarities in the IR vibrations of the different metal carboxylates and considering the instrumental resolution (4cm⁻¹).

Fig. 5. FT-IR spectroscopy showing peaks for gypsum (G) and metal carboxylates (MS)

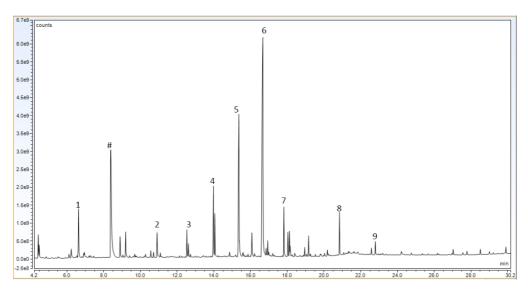
According to Py-GC/MS, the majority of the "drips" was composed of a substantial amount of difatty acids (such as adipic, glutaric, pimelic, azelaic, suberic and sebacic acids, being azelaic the most abundant) (Fig. 6). In the chromatograms of the deposited drip material some differences were observed according to the drip morphology. In comparison, the amorphous formations had higher amounts of difatty acids than both the "cubic" formation and

Fig. 6. Py-GC-MS results after thermal desorption and thermal degradation using TMAH. Difatty acids (2 = glutaric, 3 = adipic, 4 = pimelic, 5 = suberic, 6 = azelaic, 7 = sebacic acids as methyl esters) are mainly present, together with 1 = glycerol, 8 = palmitic and 9 = stearic acids as methyl esters. Peak labeled as # is due to TMAH

It almost seems that there has been leaching that, with percolating water, has conveyed the most hydrophilic part of the lipidic binder, specifically the difatty acids. Within the "liquid drip" samples only traces of fatty acids and alkenes were identified. This indicates high amounts of fatty acids found in the former solidified drips is likely to be a build up after recurrent water infiltrations. Meanwhile, the presence of the alkanes possibly relates to the traces of beeswax found in the painting mixture in the 2004 technical study [3-5]. However, beeswax is known to be insoluble in water hence this outcome of migration of the alkanes with the presence of water is not yet understood.
