## CONSERVATION OF 19<sup>th</sup> CENTURY DEFENSIVE STRUCTURE. THE CASE OF FORT SWOSZOWICE IN CRACOW, POLAND

*This paper discusses the issues associated with conservation of selected elements of the existing military object. The subject was presented on the case of Fort Swoszowice, which is the late 19<sup>th</sup> century defensive structure recently renovated and adapted to new function. Fort Swoszowice belongs to the system of fortifications that were built in concentric rings around the city of Cracow during Austro-Hungarian monarchy. After decades of neglect, the fortifications are getting more attention as important parts of the cultural heritage of the city. One group of problems associated with conservation of the structure addressed the technical condition of the materials: concrete, brick and metal elements, which showed the signs of deterioration due to lack of proper conservation. The other group of problems were connected with military purpose of the building. The descriptive methodology was chosen as the most appropriate for the case study. The archival maps and manuals were studied in order to get knowledge on the conditions specific for the military structure. Fur

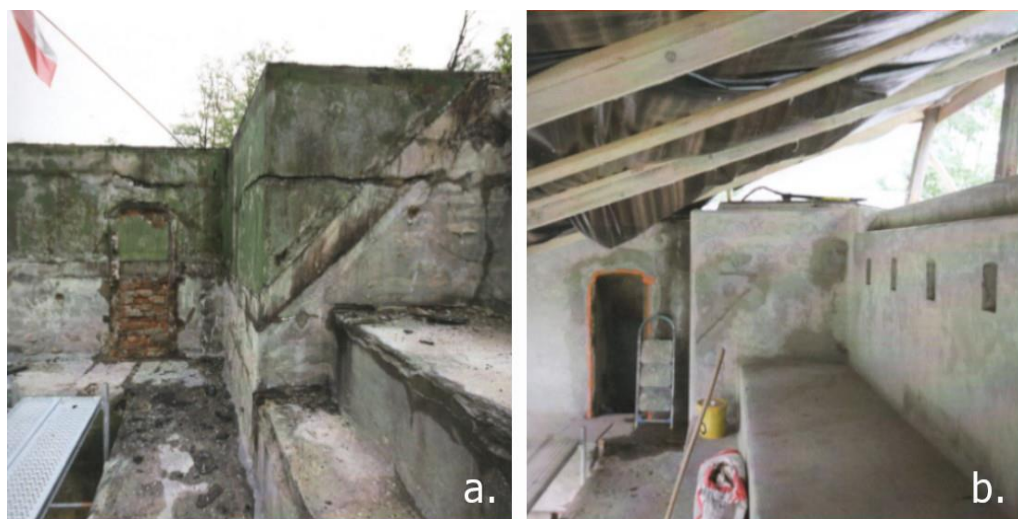
During the works it was possible to inspect in detail the technical condition of the gallery after the disassembly of the secondary roofing (Fig. 5). The concrete there was covered with a layer of dirt caused by weather conditions. The inspection also revealed cracks and a moderate degree of concrete corrosion, sometimes cavities in the aggregate revealing thicker aggregate fractions (gravel). Concrete elements of the gallery were covered with mortars and brick walls which were used for the roofing. Niches for bullets were partly bricked up and sealed with mortar, and technical openings for fitting steel sheets were sealed with wooden pegs and mortar.

**Fig. 5.** The condition of the shooting gallery after the disassembly of the roof (a.) and during conservatory works (b.).

During the works the secondary fillings and walls covering some niches were removed in order to restore the original disposition. The concrete surface was cleared of all secondary mortars. Corroded fragments of concrete were removed mechanically. The surface was cleared by means of abrasive blasting, repainted layers were removed, cracks were filled up with mass based on the cement binder modified with Sto Crete BE Haftbrücke polymers by Sto. A repair and reprofiling layer were applied by means of ribbed steel wire clamps protected with anti-corrosive aerosol. Bigger cavities and cracks in concrete were filled with mortar based on hydraulic cement. A two-component waterproofing layer was applied, consisting of acrylic mass with the addition of Portland cement with an embedded armoured reinforcement mesh and anti-alkaline impregnation. Vertical planes of the flat roofs were levelled and provided it with a texture and character as close as possible to the original surface of the natural fortress concrete. To this end, mineral mass reinforced with glass microfibre Faserputz by Sto was used. Water draining canals in the concrete flooring of the gallery by the passageways were uncovered and preserved.

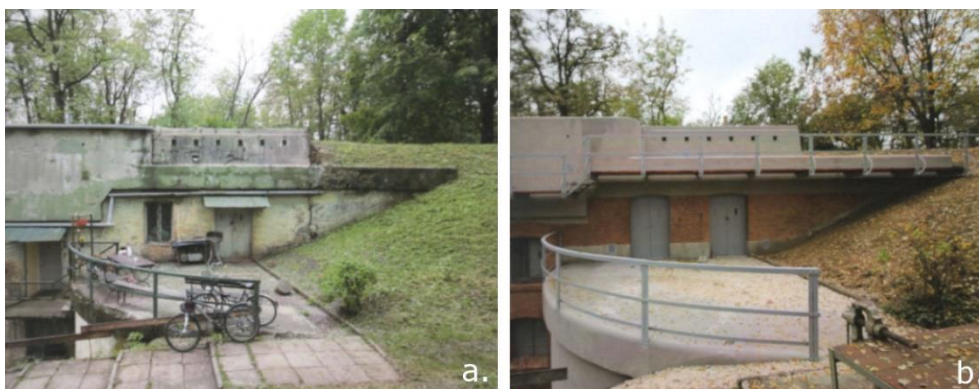
The bricks of the elevations were covered with a layer of dirt caused by weather conditions and repainted with green oil paint. In several places a yellow layer was visible from underneath the green paint. It is in line with Austro-Hungarian guidelines on painting elevations of forts in the Przemyśl Fortress – the walls were painted with perishable paints so that the colour of the elevations could be changed depending on the seasons (green in summer, most probably white in winter). This served the purposes of camouflage. In the Swoszowice Fort it was decided to restore the natural colour of bricks, without any camouflaging painting.

Some of the bricks were corroded, there were cracks and cavities in the wall structure, there were also fillings with cement-lime mortar visible. The eastern part of the barracks had not been protected against dampness, a considerable crack requiring to be repaired was noticed (Fig. 6).

**Fig. 6.** Condition of the eastern elevation prior to the commencement of works (a.) and after their completion (b.). Visible repainting, cracks, and cavities in the brick wall, as well as altered brickwork and sizes of openings.

In order to liquidate the oil paint layer, attempts were carried out to jet clean the bricks by means of different methods: hydrodynamic, chemical, abrasive blasting with quartz dust, abrasive blasting with a biological agent. The mechanical cleaning method can lead to surface damage, however, as observed by S. Samolik et al; brick in general is less fragile than plaster or limestone. Therefore, despite its disadvantages mechanical cleaning is often chosen as the basic method of removing the unwanted layers, due to its simplicity and low costs [26]. Eventually, low pressure abrasive blasting was chosen, varied depending on the strength of bricks, by means of quartz dust and biological cleaning Gumage. This way oil layers and dirt caused by weather conditions were removed from the bricks. Corroded bricks and joints around the main entrance to the fort and around certain window frames were removed mechanically by manual chipping. Secondary walls in the eastern part of the barracks were eliminated, as well. Graded spraying impregnation was applied with the use of impregnates for strengthening weathered and loosened surfaces, based on ethyl esters and silicic acid KSE 100 and KSE 300 HV by Remmers.

As it turned out, it was necessary to reconstruct the brickwork. To this end full construction bricks were used, arranged in compliance with the principles of fortress brickwork. Cavities in bricks and joints were filled with a body-tinted mineral mixture in local colours by Hufgard Optolith and Optosan TrassFuge. The colours of putties and discolourations were merged with original colours of individual bricks by means of silicate glazing Restaurolasur by Keim and a silicate binder to glazings Optomal fixative by Hufgard Optolith. For the purposes of protection against weather conditions, brickwork hydrophobisation was carried out using the silane-siloxane solvent preparation Funcosil SL by Remmers.

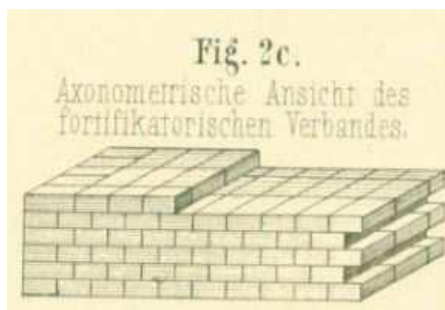
It should be pointed out that brick walls (Fig. 7) of the fort were made in line with fortress building rules, i.e., only the heads are visible, all wall layers are the same. Joints between adjacent layers are shifted relative to each other by half the width of the brick (by half of the head). Due to the high strength of the wall, this method was used to build walls of forts, citadels, and other defence facilities. Further development of artillery, however, forced a departure from bricks in favour of more durable materials, most of all reinforced concrete and steel.

**Fig. 7.** The way of arranging bricks with the head facing the front of the wall. The so-called fortress binding of the wall (*Fortifikatorischer Verband*), Source of illustration: *Constructions-Details der Kriegs-Baukunst, Band I.*, Wien 1878; Table No. 4 “Mauern, verschiedene Ziegel-Verbände”.
